# Facility Condition Assessment

**MINNEAPOLIS POLICE DEPARTMENT**

NOVEMBER 10, 2023

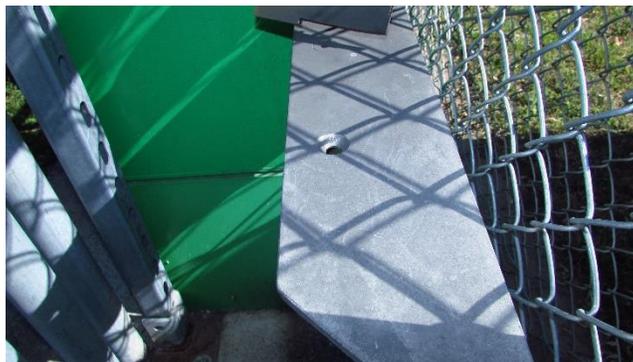
Motorized Gate 'Rail' Freezes up in the Winter

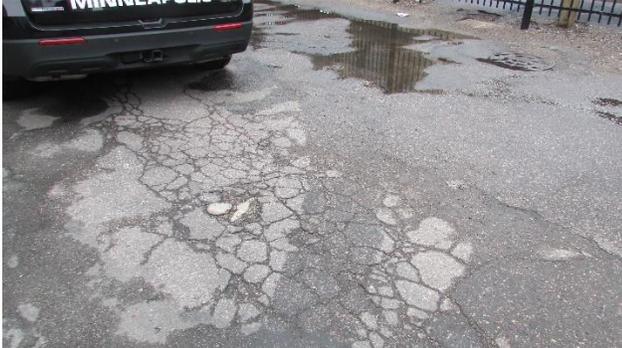
- 101-001** The asphalt parking area on the south of the building is significant deteriorated with lots of ponding. Staff have reported sprained ankles as a result of the many potholes.
- 101-002** There are many stains on the carpeting in Rm 100 - Community Room.
- 101-003** There are a variety of locations where the exterior steps/elevated walkway and exterior brick are deteriorating.
- 101-004** According to Property Service Staff, only two of the existing four compressors in the air-cooled chiller are operational. It is recommended that either new two compressors be installed, or if necessary, the chiller be replaced.

Cracks/Deterioration in Asphalt Parking Lot

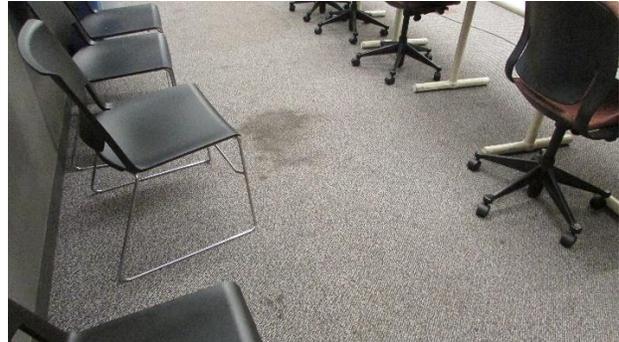
Rm 100 - Community Room - Carpet Stains

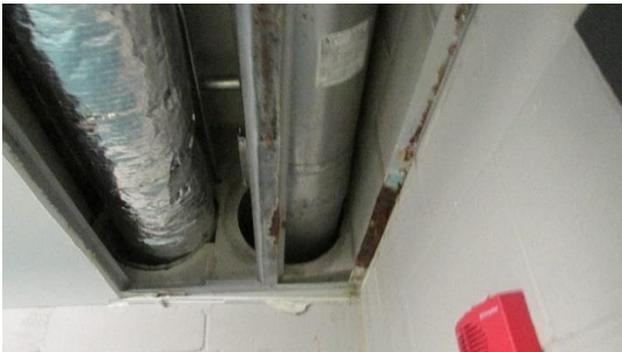
- 101-005** There is damage to the ceiling in the basement Men's Locker Room (Rm 005) due to water penetration from the AERCO boiler stack extending to the roof. This is also causing premature deterioration of the boiler stack as evident by the corrosion.

Rm 005 - Men's Locker Rm - Ceiling Damage

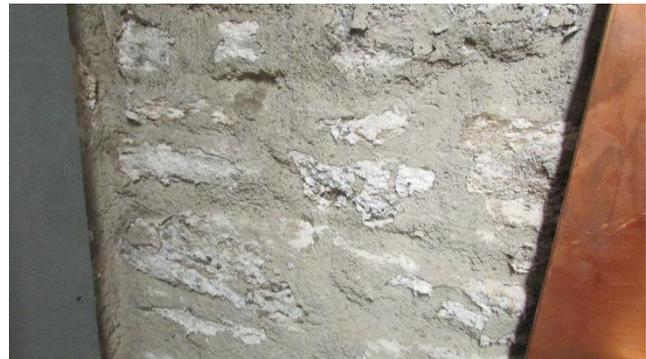
- 101-007** It was noted during the on-site evaluation that there are many locations where the original stone interior foundation has surface efflorescence including surface deterioration / flaking of the stone/masonry.

Rm 001 - Mech Rm - Foundation Surface Deterioration

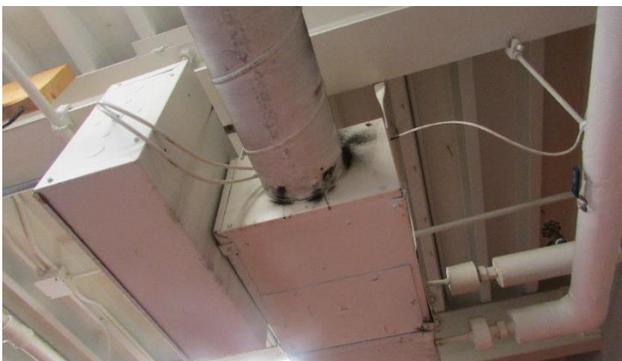
- 101-013** There is a black dust/grime that is being expelled from the VAV box located in Rm 127 - Bicycle Storage. Additionally, it was noted during the on-site survey that there are various locations of dirty diffusers and return air grilles. It is recommended that all grilles, diffusers, and ductwork be cleaned.

Rm 127 - Bike Storage - Black Dust/Grime from VAV Box

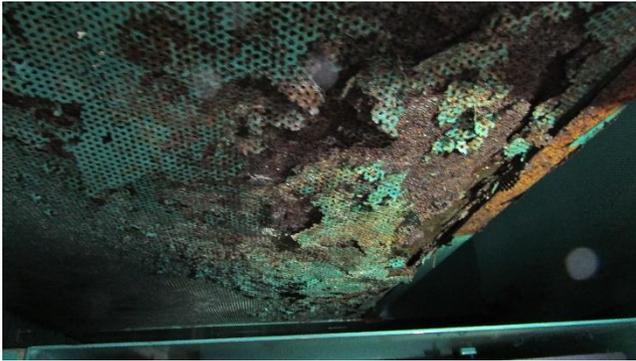
- 101-006** Although the emergency generator located on the lower roof is known to be functioning as designed, there is water that is leaking into the generator resulting in deterioration that is occurring on the sound baffle and inside the enclosure.

Deterioration Of Sound Baffle Inside Emergency Gen

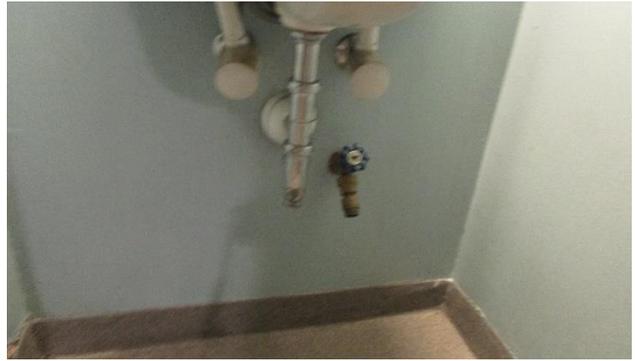
- 101-009** Toilet rooms designated as being accessible are missing pipe wrap under the accessible sinks. It is recommended that pipe wrap be installed to prevent injury to individuals in a wheelchair.

Lack of Pipe Wrap in Accessible Labeled Restroom

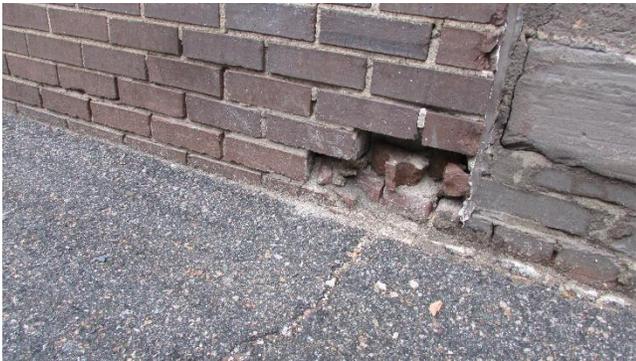
Exterior Brick (Eastside) Needs to Be Repaired

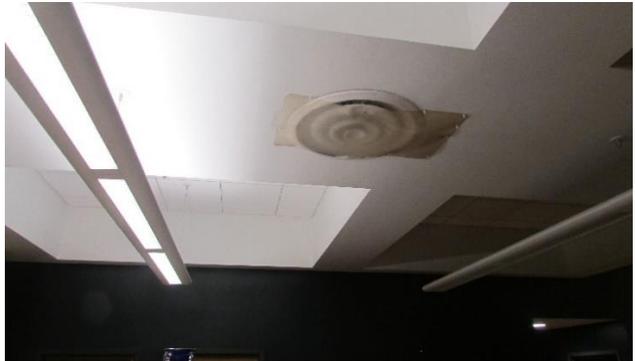
Plastic Covering Supply Diffuser On 2<sup>nd</sup> Floor Open Office

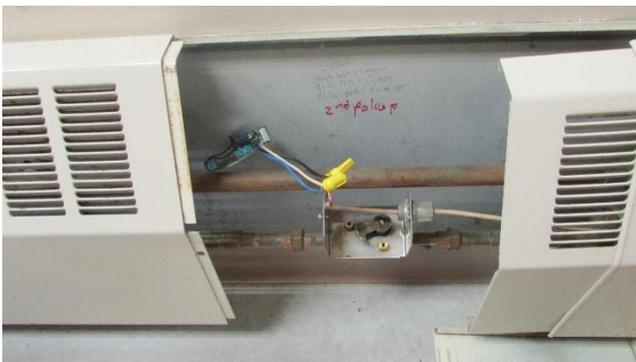
- 102-016** One of the vertical components of a toilet partition in Rm B4 - Women’s Locker Room needs to be re-anchored to the wall.
- 102-017** Staff showed the location of a missing thermostatic control heating valve in Rm 137 - Lounge (currently temporary breakroom/kitchen) requiring maintenance staff to manually remove fin tube

Rm 137 – Community Lounge – Valve Req. Manual Oper.

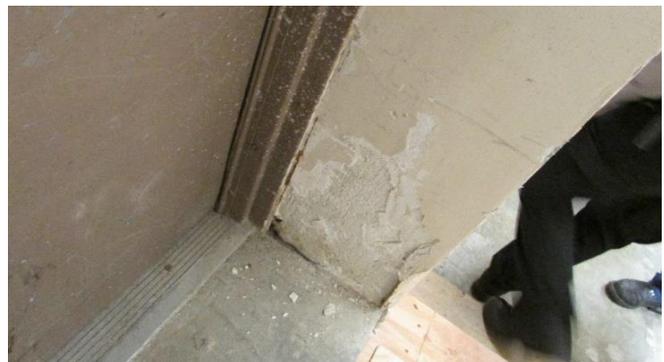
- 102-003** Plaster spalling at exterior door exit on Eastside of basement Rm B6 – Lounge should be repaired in conjunction with the remodeling of the basement areas.

Rm B6-Lounge – East Stairs Deteriorating Plaster

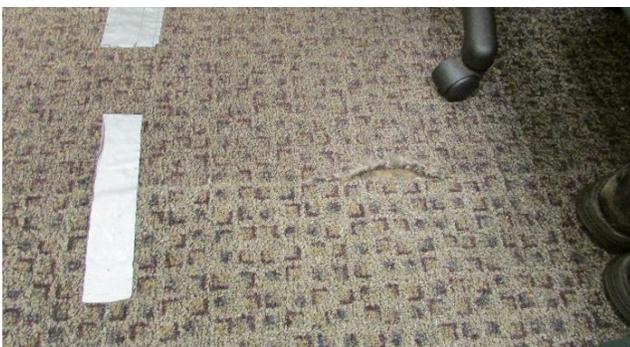
- 102-004** Carpet in many location is frayed and is taped together. Recommend that carpeting be replaced.
- 102-005** Some ponding and a variety of deterioration on the parking lot asphalt.

Rm 104 – Office Area – Frayed & Taped Carpet

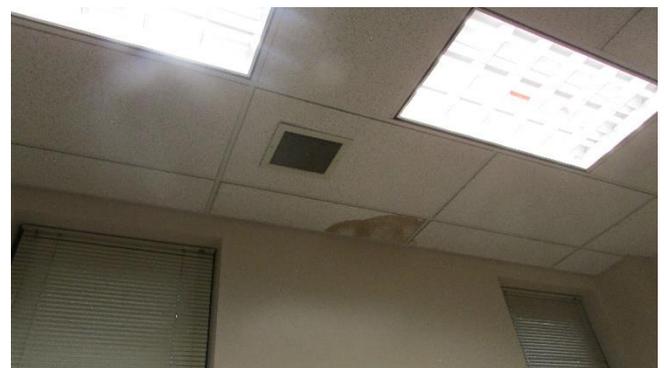
- 102-002** Rm 137 – Community Lounge has a water damaged ceiling tile (against West wall) due to roof leak. There are many other locations of water-stained ceiling tiles throughout the facility, including Rm 109 – Copy Room, Rm 111 – Corridor East, Rm 120 -Roll Call and Rm 107 SAFE Unit. Additionally, the roof has vegetation growing directly on the pebble ballast and there are a few areas where the roof insulation has been exposed. Roof sections should be repaired/replaced soon.

Rm 137 – Community Lounge Water Damaged Ceiling Tile

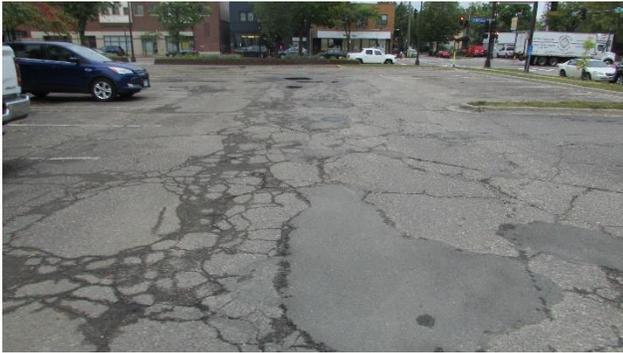
Cracks/Deterioration/Ponding in Asphalt Parking Lot

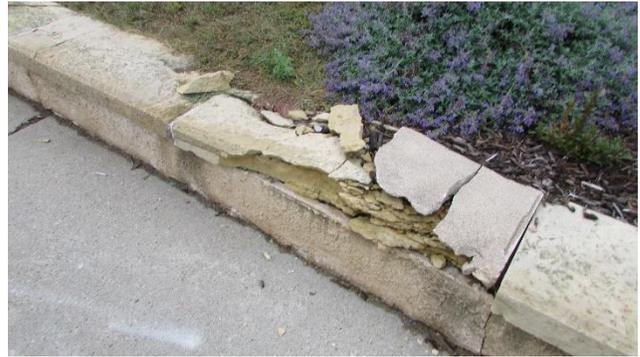
- 102-006** Small retaining wall on Eastside is crumbling.
- 102-007** Stone stairs on the Eastside of the building appear to have been previously repaired, but again are showing signs of deterioration. Steps are also missing a handrail.

Retaining Wall on Eastside is Crumbling

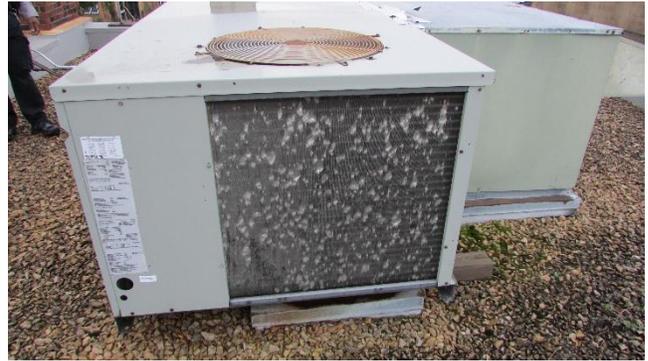
- 102-001** RTU-3 serving Rm 126 – (formerly) Workout Room has hail damage on the condensing fins, additionally, this is currently controlled by the Trane control system while remaining facility utilizes Automated Logic. Recommend standardization with a single temperature control system.

RTU-3 Condensing Coil Hail Damage

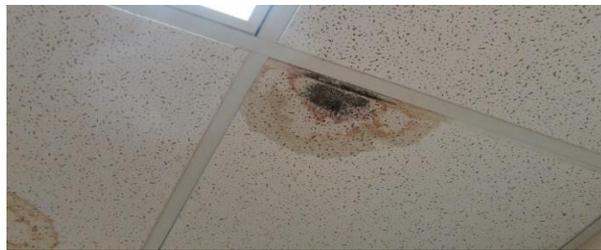
Rm 120 – Roll Call – Water-Stained Ceiling Tile

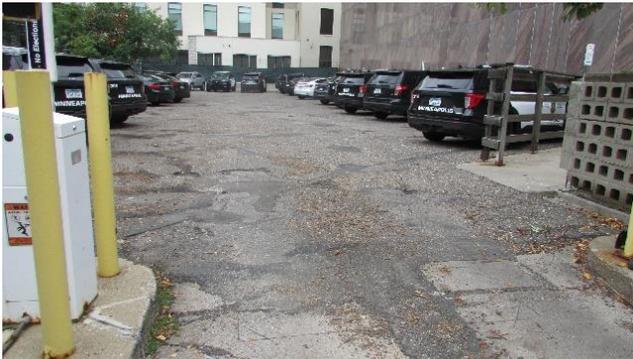
Parking Lot Cracking/Potholes/Deterioration

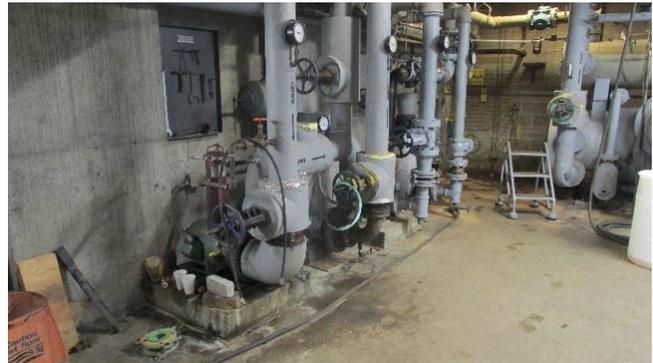
Basement – Original 1959 Pumps

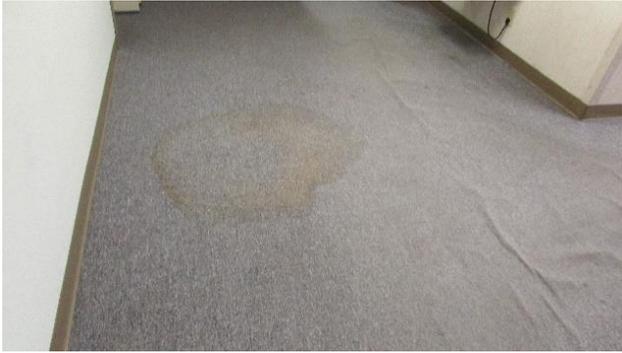
Rm 304 –Office – Significant Water Damage

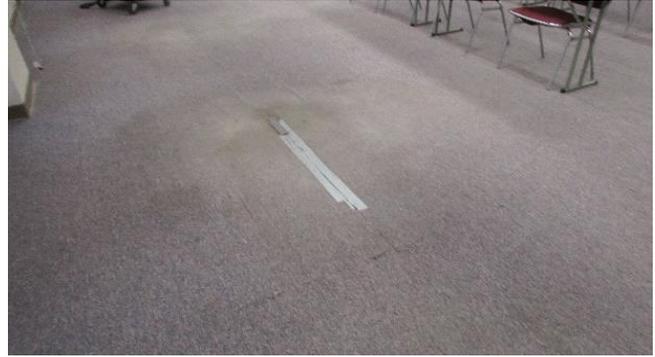
3<sup>rd</sup> Floor Open Office – Taped Carpet

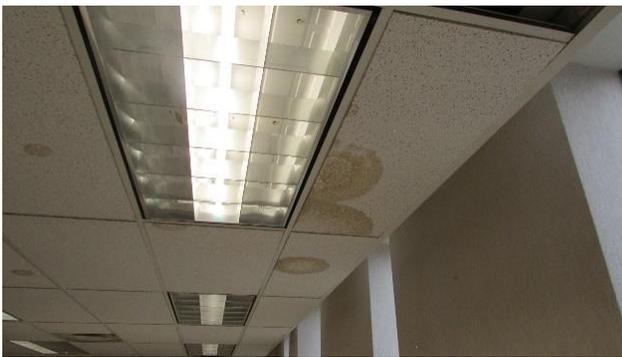
3<sup>rd</sup> Floor Open Office – Water-Stained Tiles

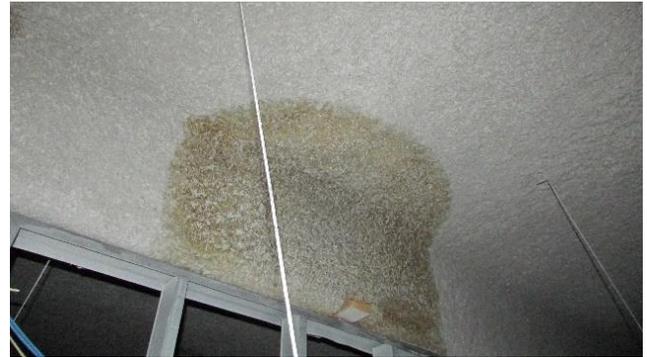
Rm 308 – Water Damage Above Ceiling Tiles

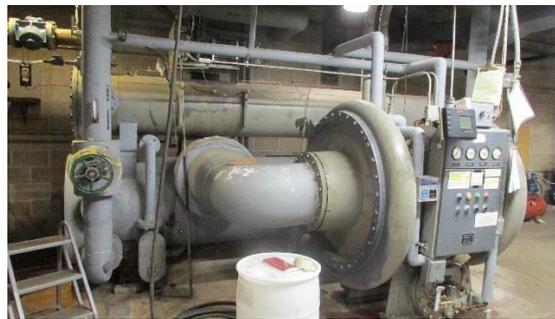
Basement – Original 1959 Chiller

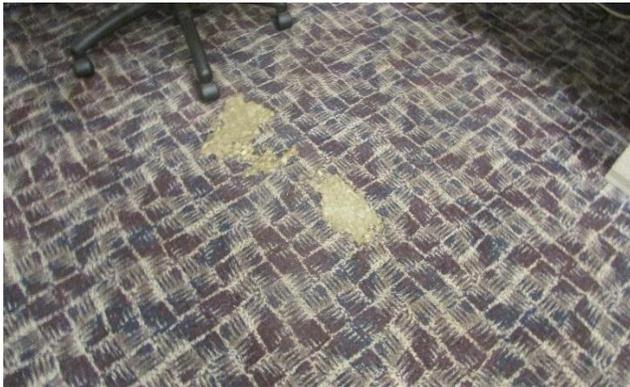
Rm 112– Office – Significantly Worn Carpet

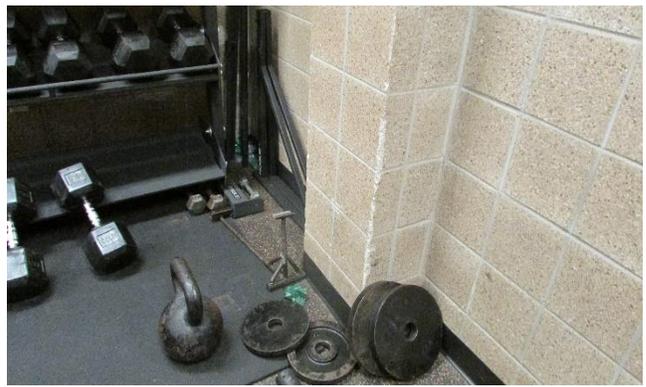
Rm B01 – Workout – Chipped Corners

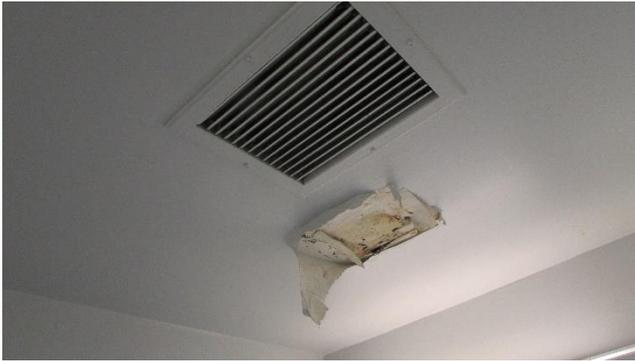
Rm 139 – Women’s (Range) – Damaged Ceiling

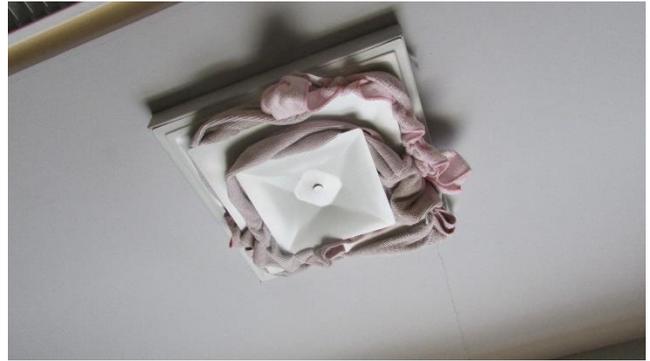
Rags Have Been Stuffed into Supply Air Diff on 2<sup>nd</sup> Flr

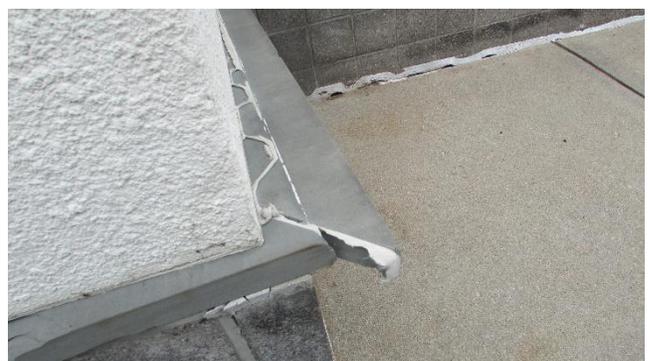
Southside - Exterior Stone Trim Piece Requires Repair

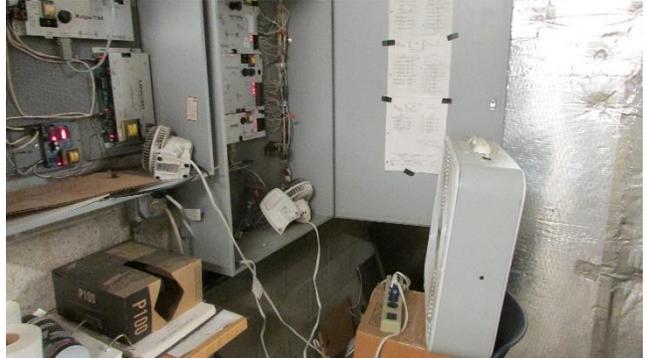
Rm B11A – Multiple Fans Cooling to Control System

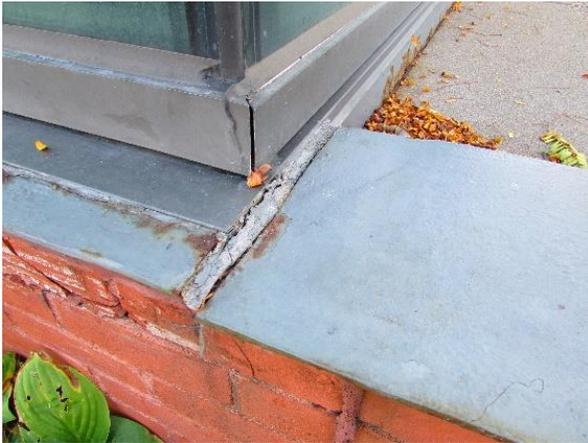
NW Failing Caulk Joint, Deteriorated Brick & Window Jt

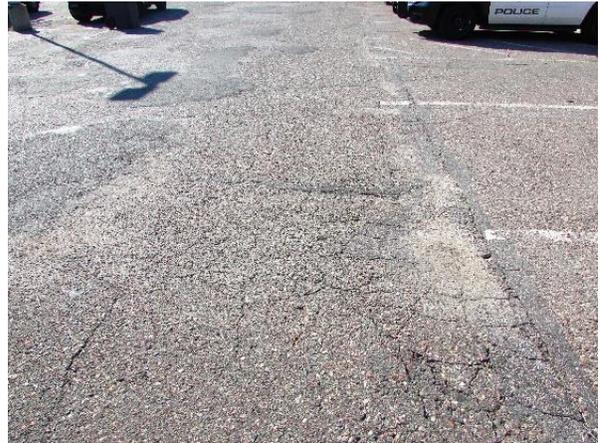
Cracks/Deterioration in Asphalt Parking Lot

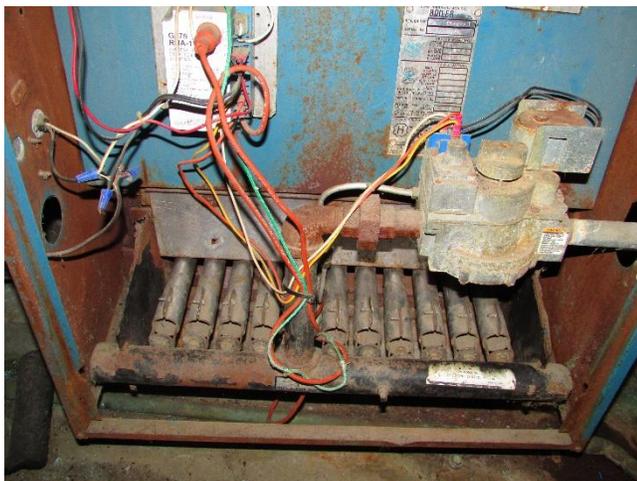
Rm 109 – Mechanical – Single Boiler Proving Htg

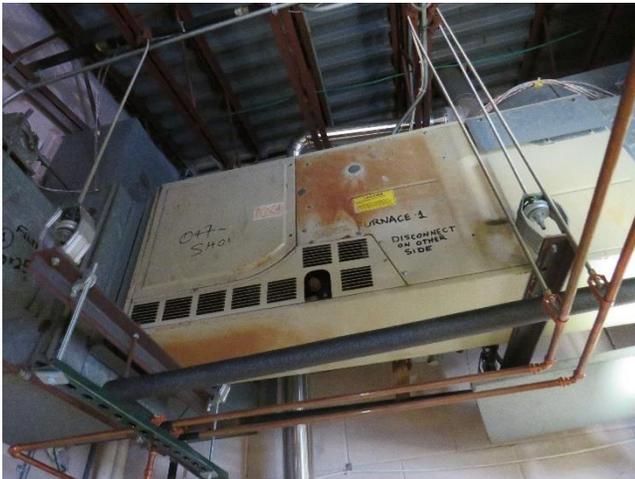
Rm 119 – Work Room – Furnace Deterioration/Corrosion

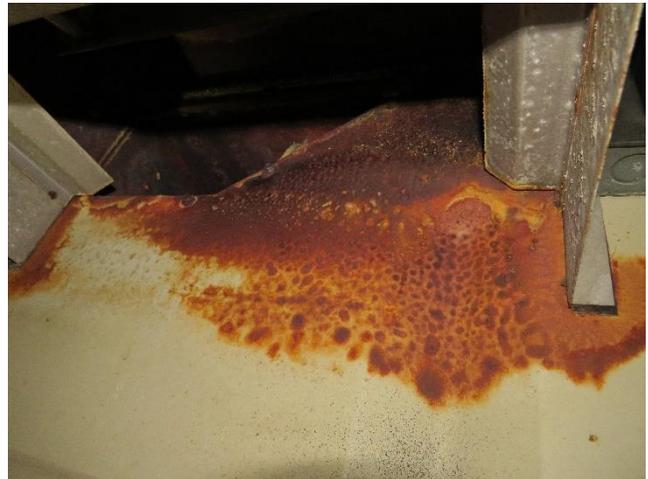
Rm 119 – Work Room – Furnace Corrosion

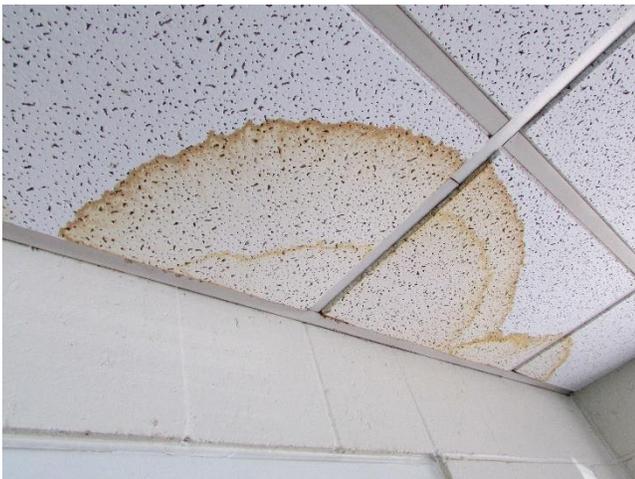
Rm 116 – Office – Water-Stained Ceiling Tiles

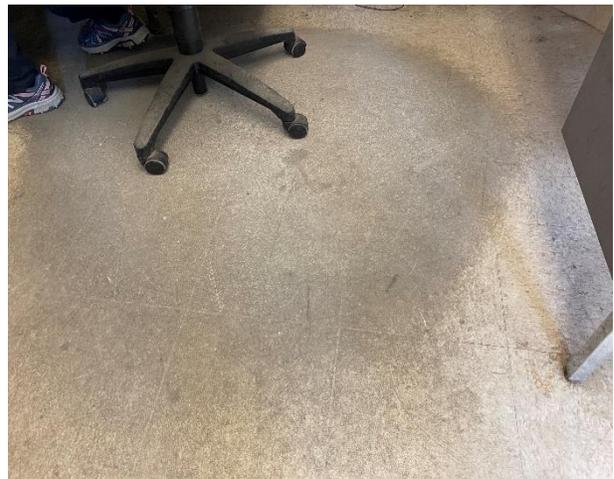
Rm 116 – Office – Worn VCT Flooring

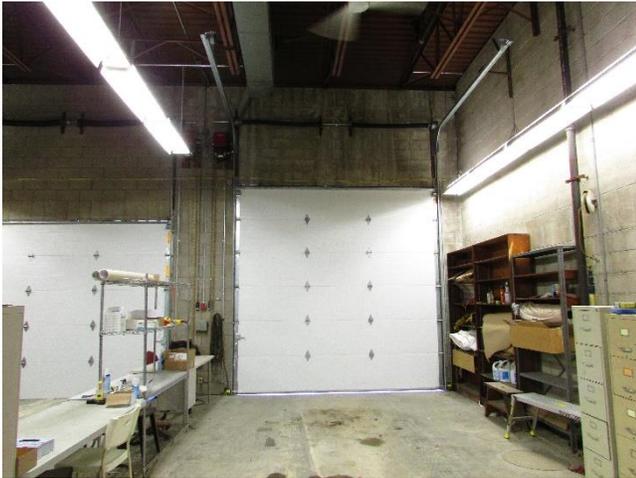
Rm 115 – Garage – Staff Would Like to Have Ltg Angled

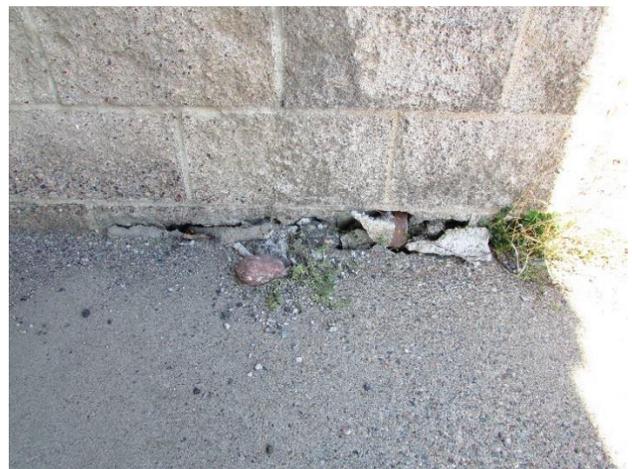
Block Deterioration at Base Near Main Entrance

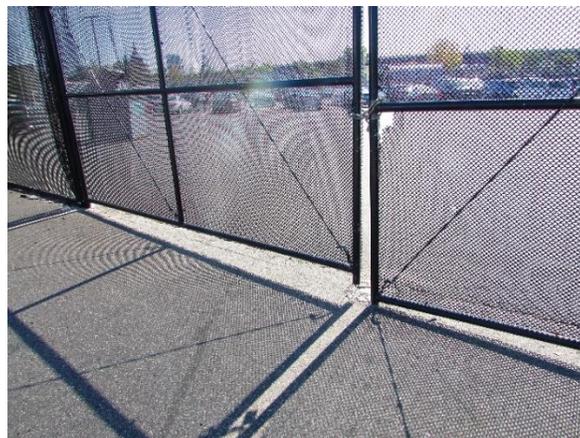
Staff Would Like Wheels Installed on Manual Gate

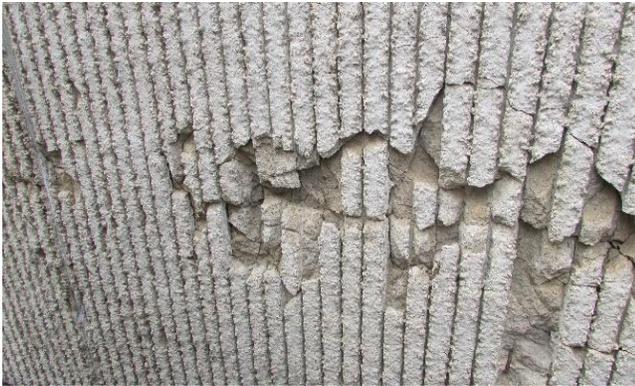
Example Of Damage/Holes in East Side Exterior

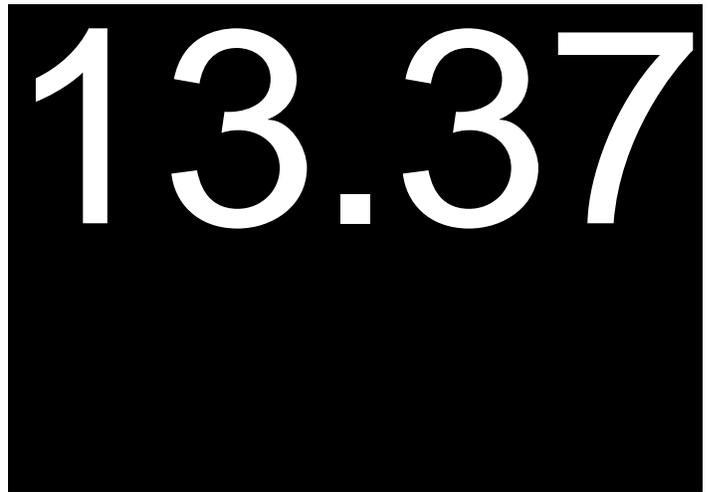
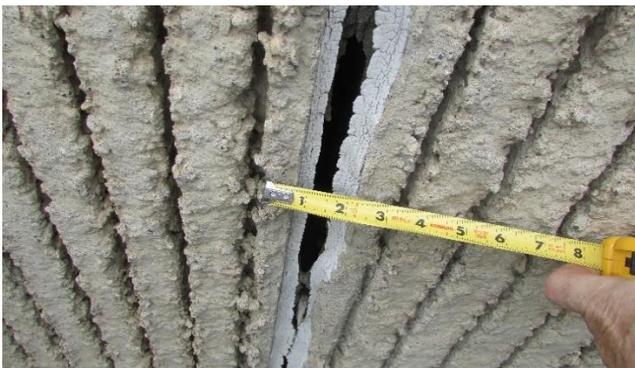
Example Of Recaulking Needed in East Side Exterior

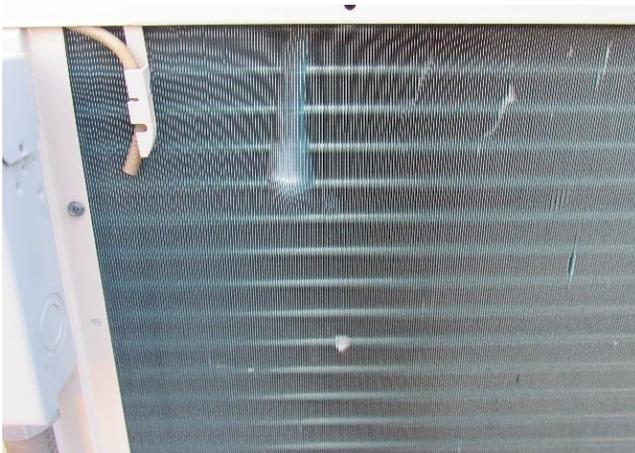
Roof Top Condensing Unit Hail Damage

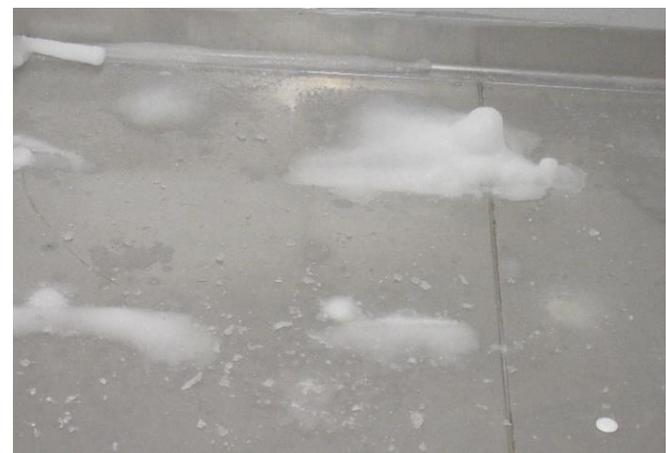
Freezer Ice Build Up

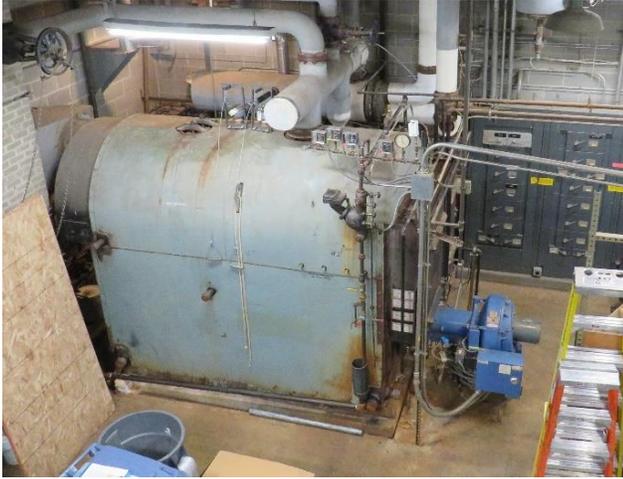
Rm 138 – Utility Room – Single Steam Boiler

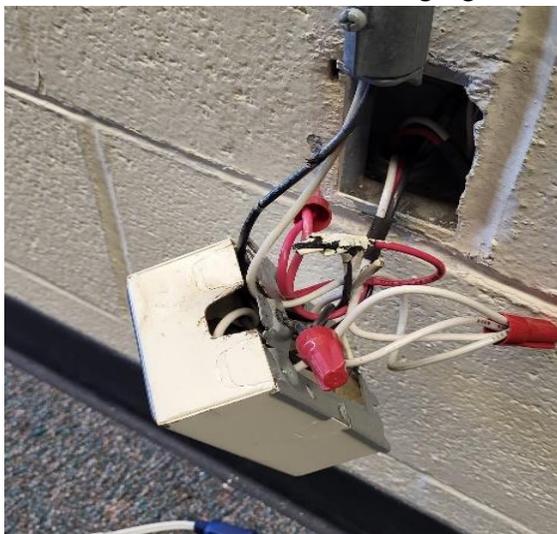
Rm 210 – 13.37 – Repair Electrical Outlet

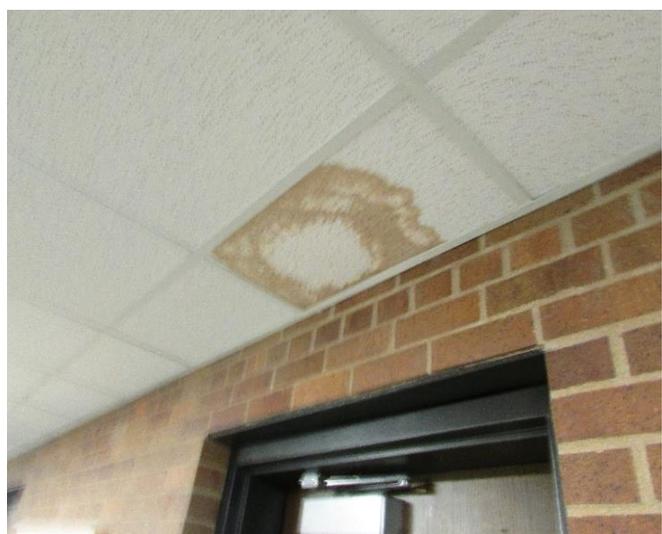
Rm 134 – N Hallway – Water Stained Ceiling Tiles

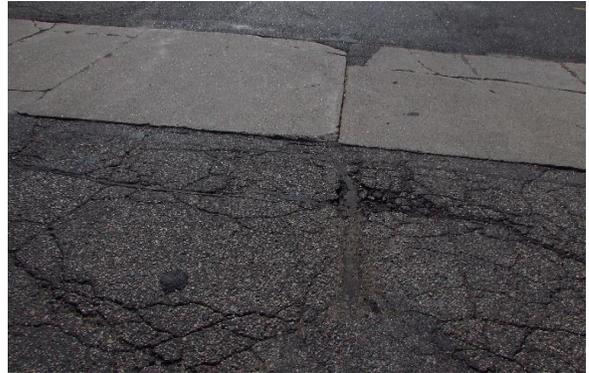
Cracks/Deterioration in Asphalt Parking Lot

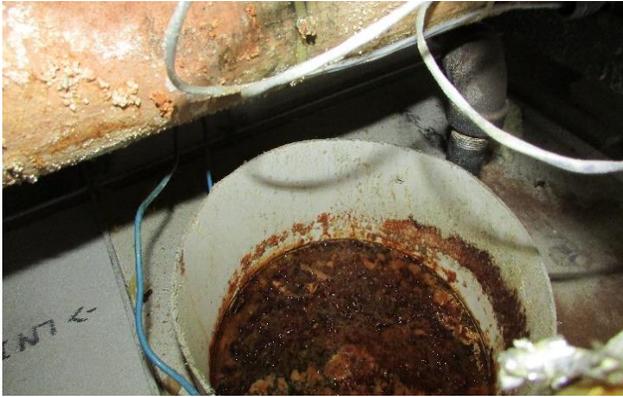
POR: Bucket Used for Hot Water Leak Collection

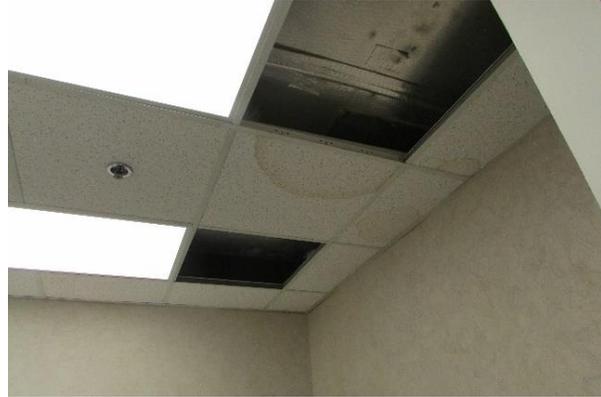
POR: Water-Stained Ceiling Tiles

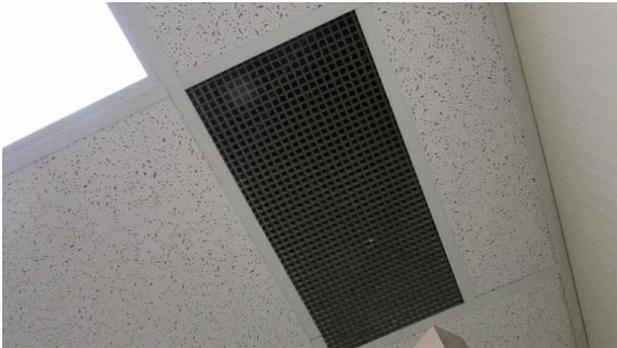
POR: Dirty Diffuser

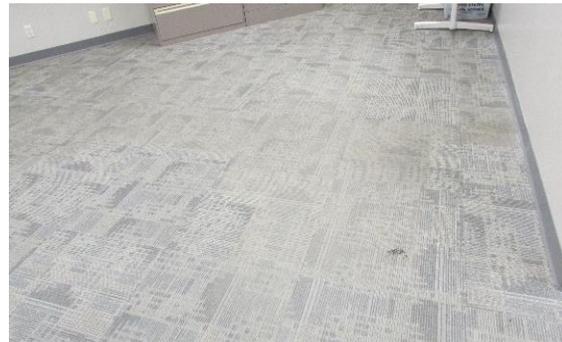
Worn & Stained Carpeting

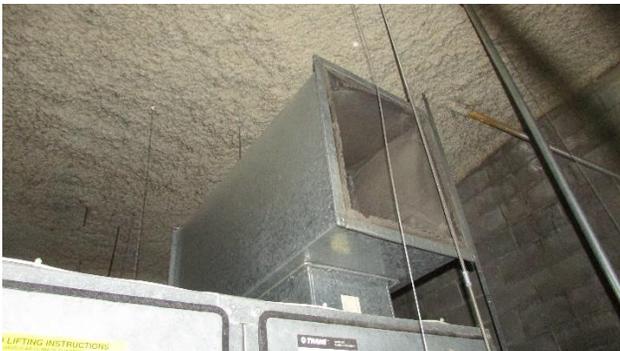
Traffic: Return Air Duct – Drawing Air from Above Ceiling

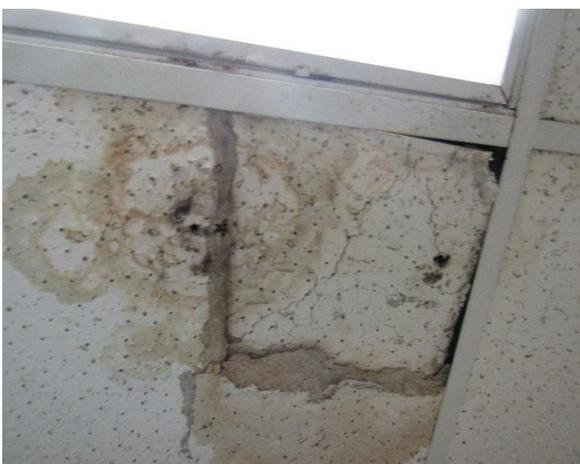
Rm 17 - Comm. Rm – Signif. Water Damaged Ceiling Tile

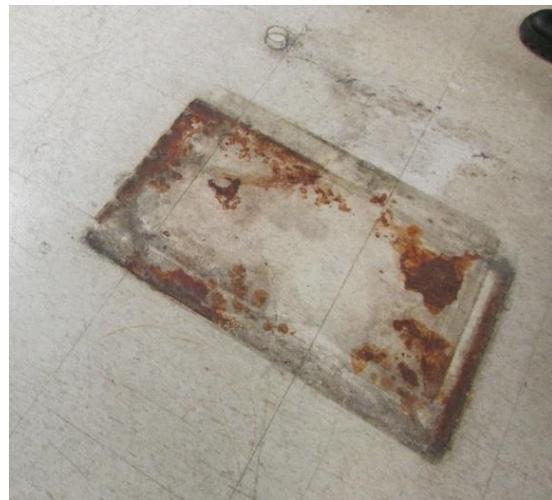
Rm 11 – 13.37 – Existing Flooring

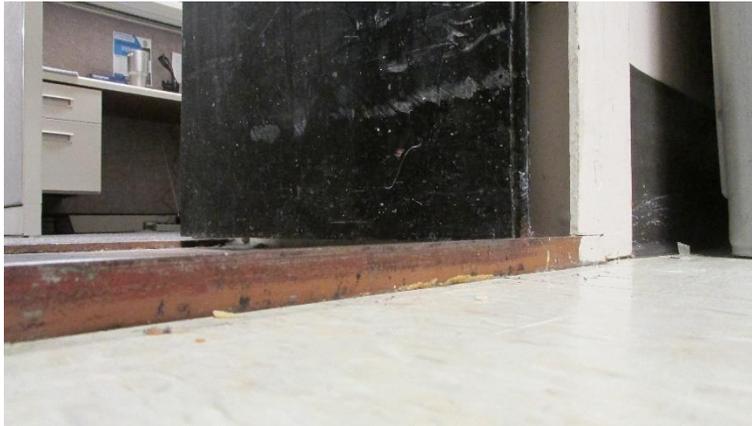
Rm 112-06 Old Safe Door Frame Trip Hazard

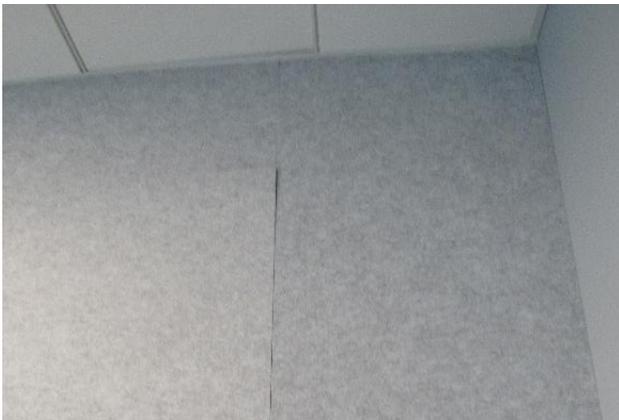
Wall Covering Coming Unglued in Conference Rooms

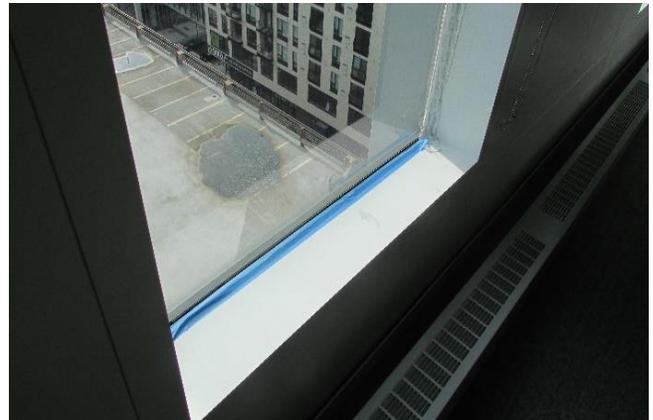
Broken Window Glazing on Southeast Side of Building

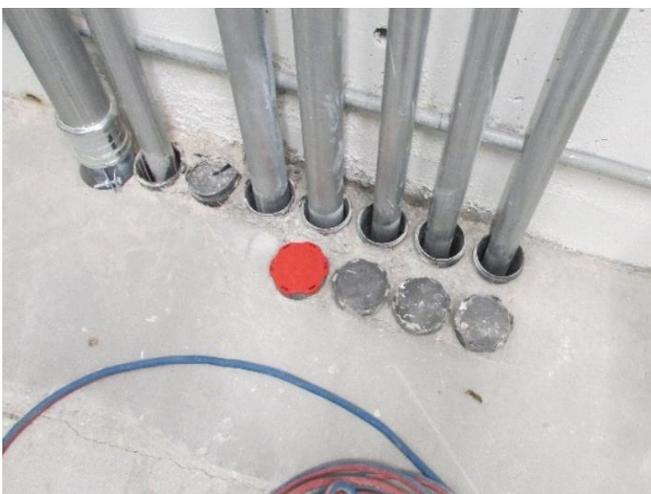
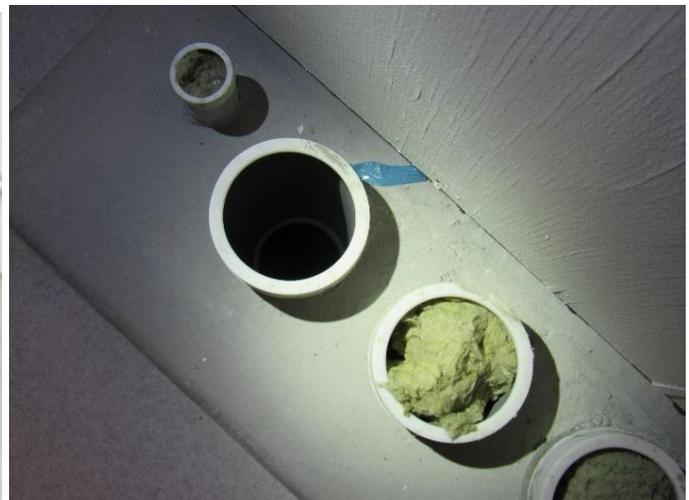
Lack Of Fire Stopping Around Elements in Elec/Telecom Rooms (Photos From 9<sup>th</sup> Floor Elec/Telecom Rooms)

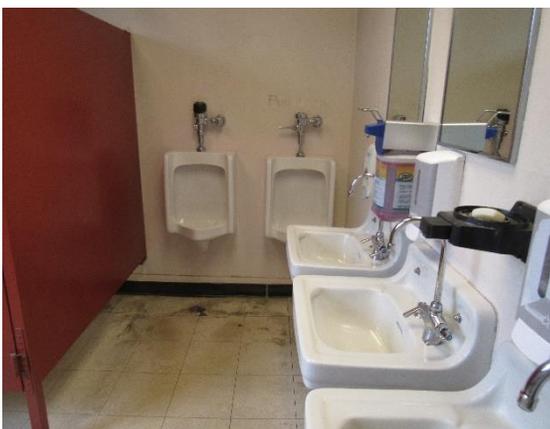
Toilet Room Dated Interiors

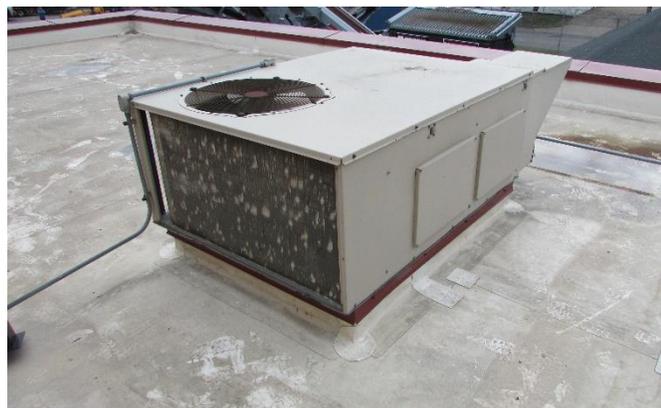
Hail Damage Visible on RTU's

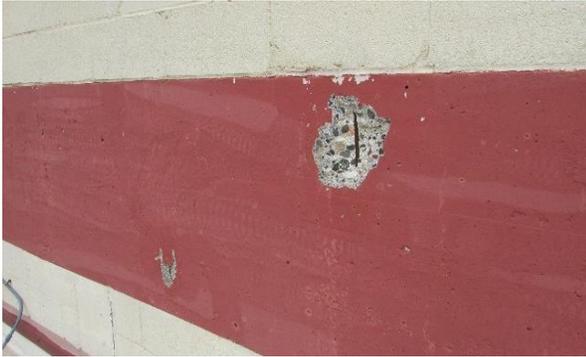
Damage On Exterior of Building

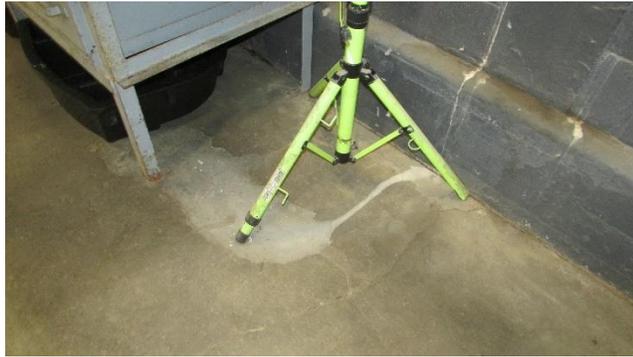
Evidence of Roof Leak Located on East Side
