# Evaluation of Bicycle Traffic Control Devices and Street Design Elements in Minneapolis

March 13, 2017

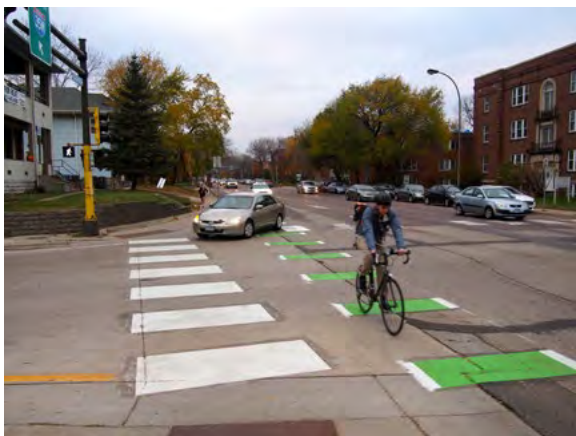
Figure 3-14: Example of modified dotted green conflict zone through an intersection

Since this original installation, Public Works has modified the design of the colored conflict zones based on additional observations at the Blaisdell Avenue South and Lake Street west and at the 15<sup>th</sup> Avenue SE and Rollins Avenue Southeast locations. At these intersections, a large share of drivers were avoiding the solid green and merging after the green. This was also observed to some extent at the 7<sup>th</sup> Street North and East Lyndale Avenue N location. As a result of these observations, Public Works has modified the solid marking to be a dotted green marking to encourage drivers to merge at the intended location.

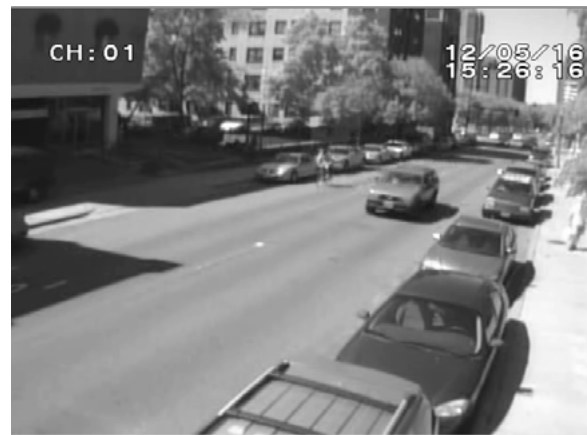
Figure 5-9: Screen capture of after video of LaSalle Avenue South between 15th Street West and Oak Grove Street West

After the enhanced shared lane markings were installed, three percent of southbound bicyclists rode to the left of the shared lane marking, 88 percent rode over the shared lane markings, one percent rode to the right of the shared lane markings, six percent rode on the sidewalk, and two percent rode in multiple locations within the video frame. No bicyclists were observed riding in the parking lane due to the continuous presence of parked vehicles. Seventy-six percent of northbound bicyclists rode on the sidewalk.

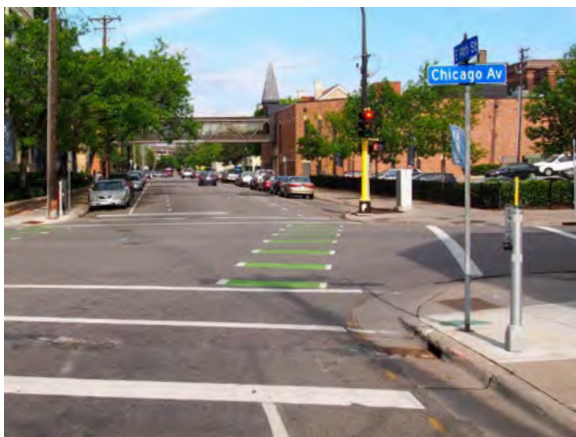
Figure 7-19: Green bicycle lane conflict markings installed on 14<sup>th</sup> Street East at Chicago Avenue South

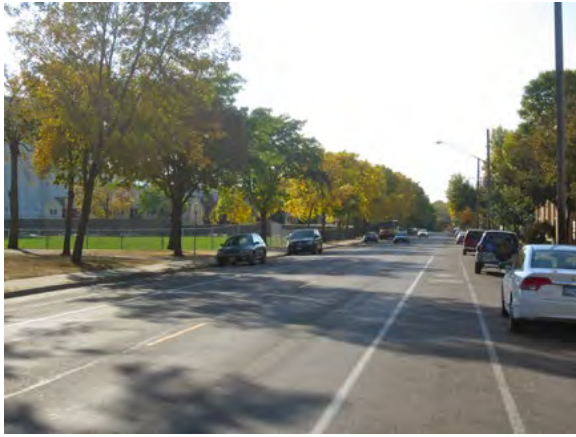
Figure 11-3: Como Avenue Southeast facing west at 15<sup>th</sup> Avenue Southeast after installation

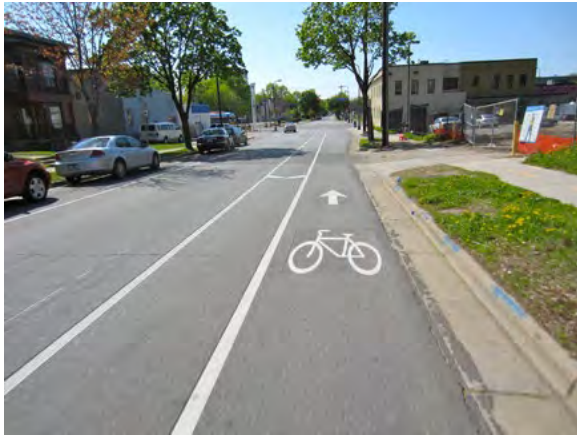
Figure 14-4: Fremont Avenue North approaching West Broadway Avenue North after installation

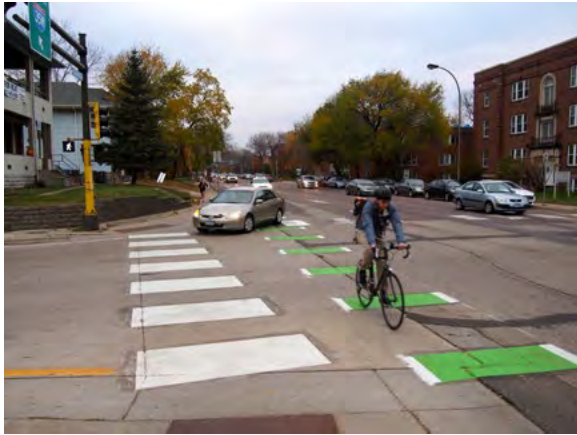
Figure 16-13: Example of modified dotted green conflict zone through an intersection

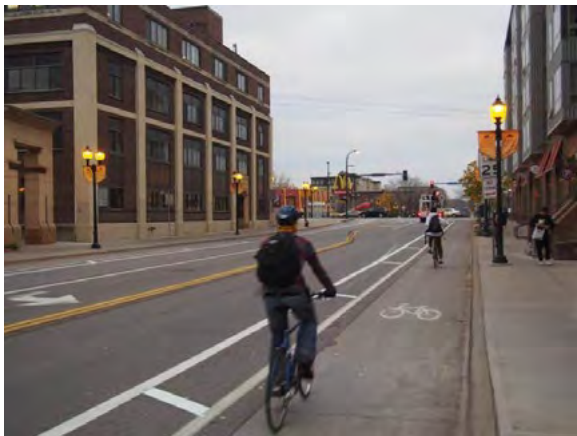
Figure 17-6: Buffered bicycle lane between University Avenue Southeast and 4<sup>th</sup> Street Southeast in 2015

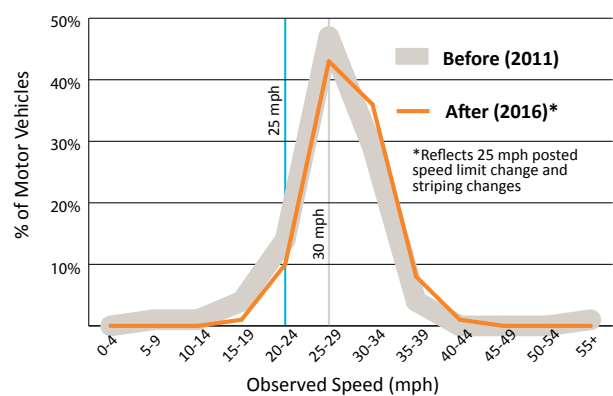
Figure 17-11: Observed motor vehicle speed distribution between 6<sup>th</sup> Street Southeast and 7<sup>th</sup> Street Southeast
