# Facility Condition Assessment

**MINNEAPOLIS POLICE DEPARTMENT**

NOVEMBER 10, 2023

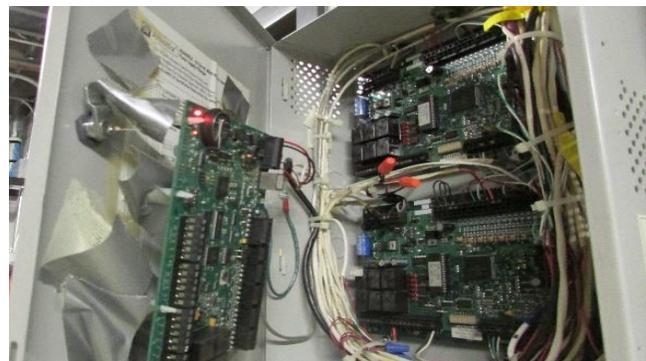
Rm 110 - Telecom - Duct Tape Used in Panel

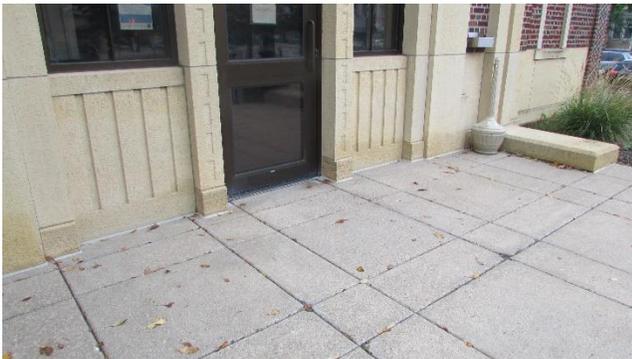
No Accessible Provisions / Signage at Main Entrance

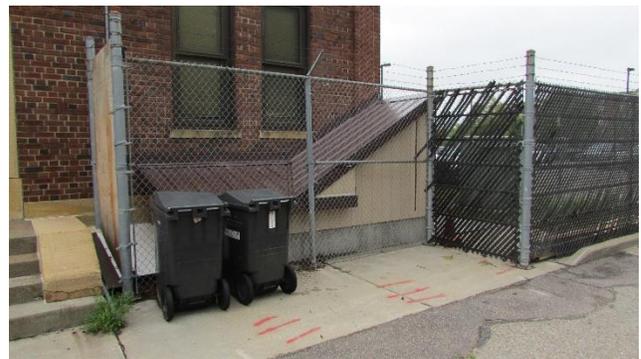
Eastside – Location of Snow Accumulation in Winter

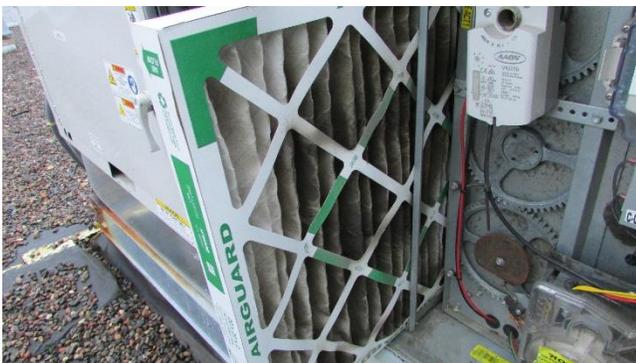
5 Ton Aeon Rooftop Unit (Pre-Filter) Needs Changing

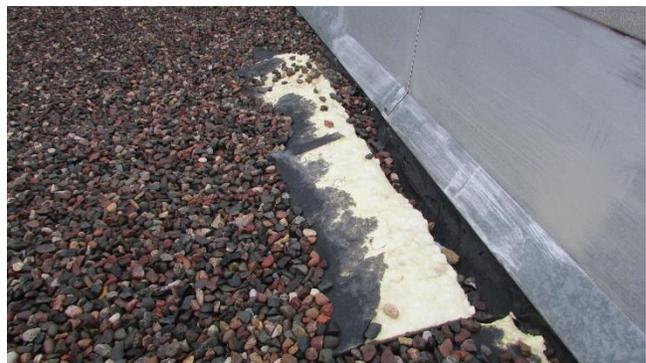
Exposed Insulation on the Roof

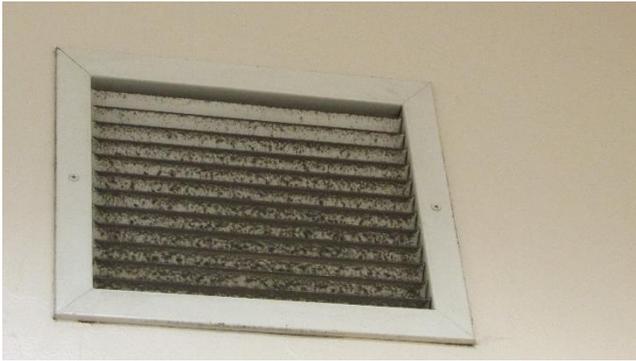
Rm 105 – Office Dirty Diffusers & Grilles

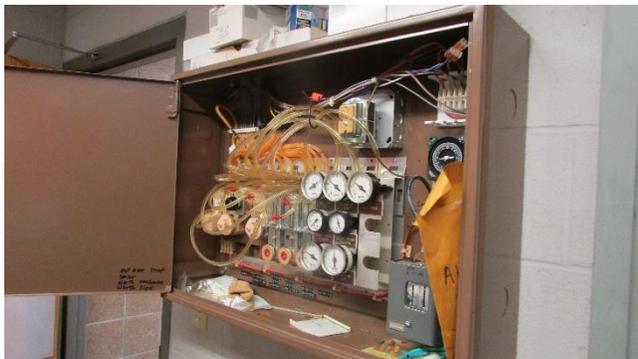
Rm 144 – Storage – Antiquated Pneumatic Controls

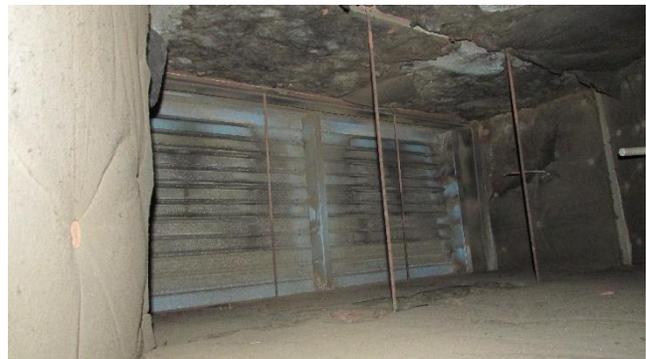
N Mech Penthse – Range MUA Unit – Dirty / Interior

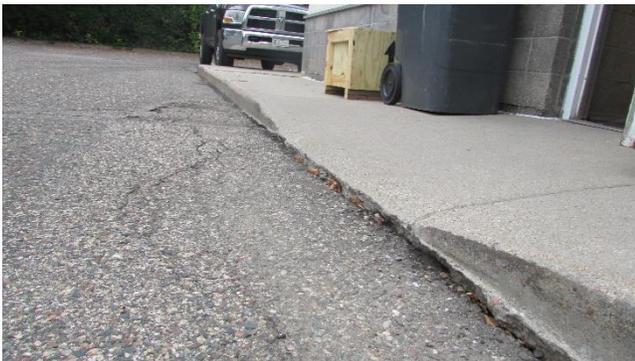
Approx. 1” Gap Between Asphalt & Sidewalk Ramp

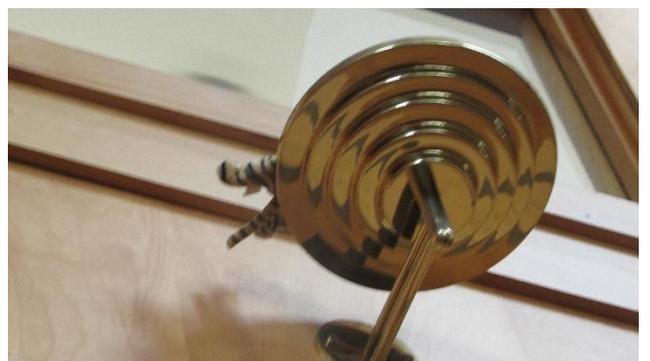
Beanie Baby Laying in Sconce Ltg Fixture – Remove

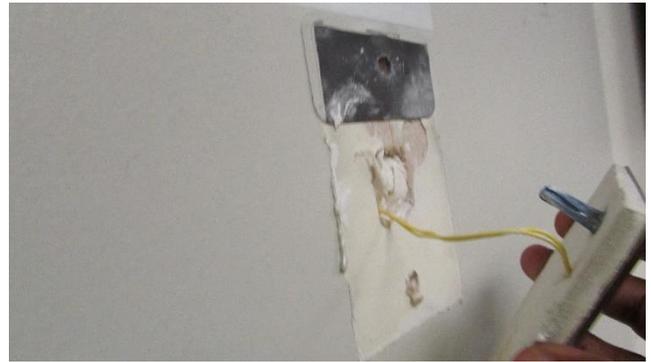
Rm 113 – Shift Office – Reattach Thermostat

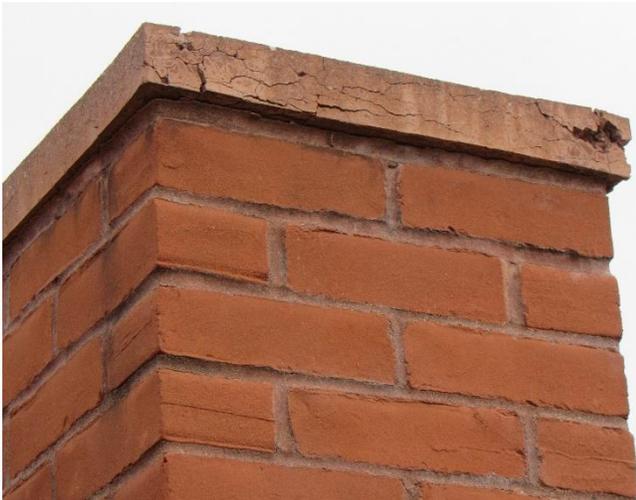
SW Brick Column (Vehicle Ent) – Crumbling Capstone

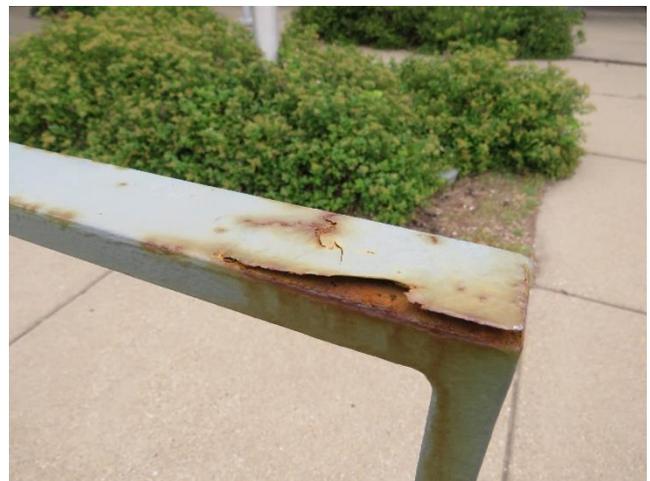
Northwest Entrance – Peeling Paint from Railing

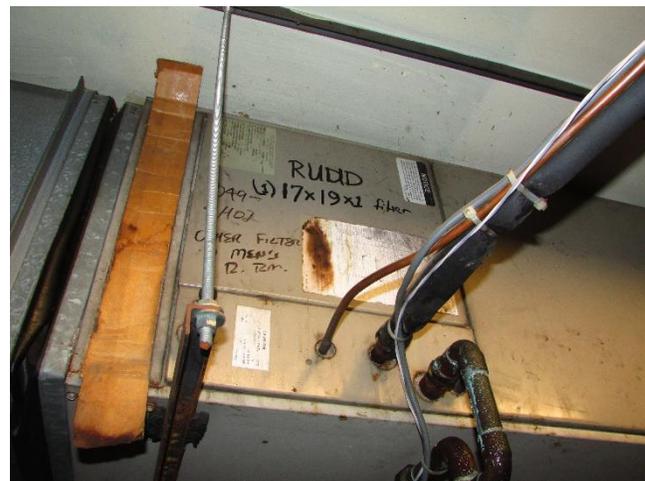
Rm 109 – Mechanical – Cardboard Used on Filter Bank

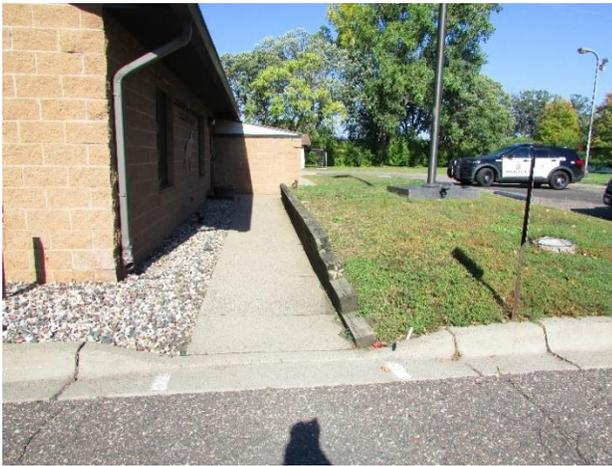
Timber Retaining Wall Starting to Lean

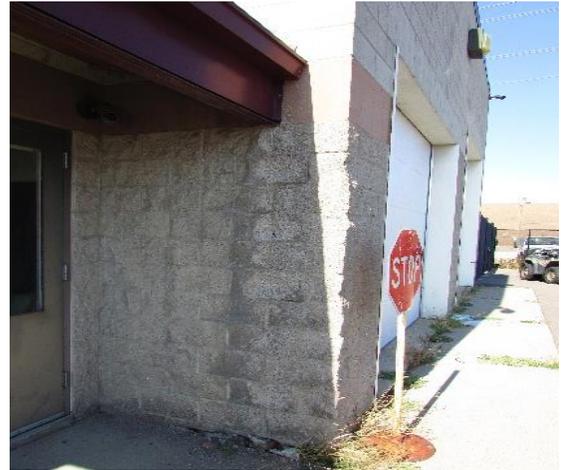
Split Face Block Erosion from Roof Water

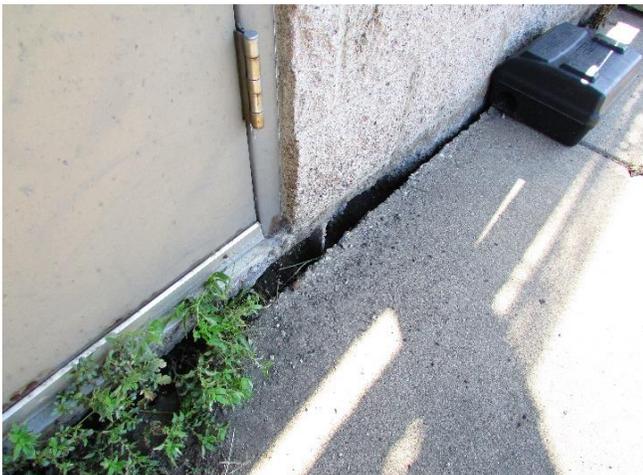
SW Corner, Drainage is Towards Building

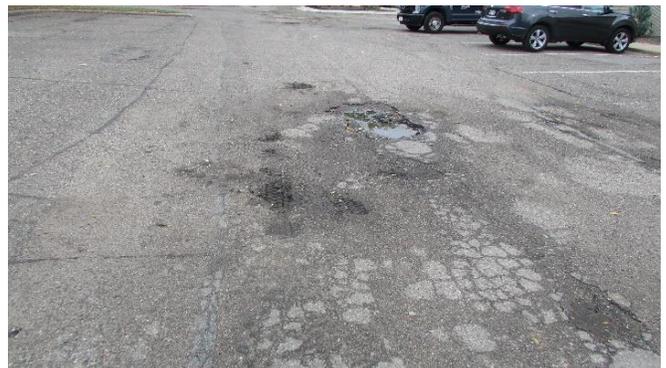
Example of West Side Parking Lot Pothole

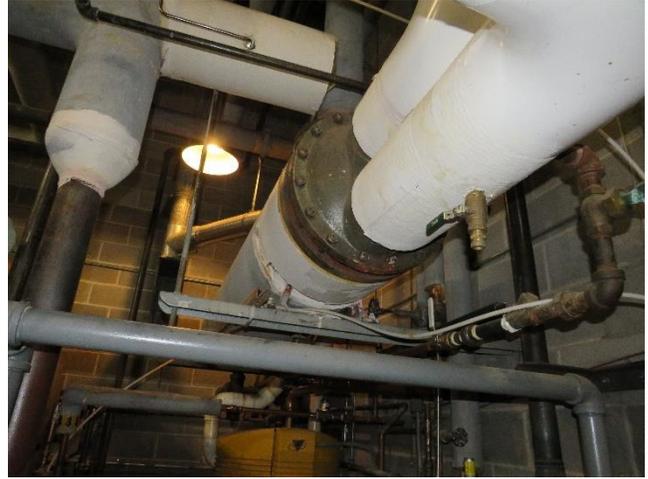
Rm 138 – Utility Room – Steam / Hot Water HX

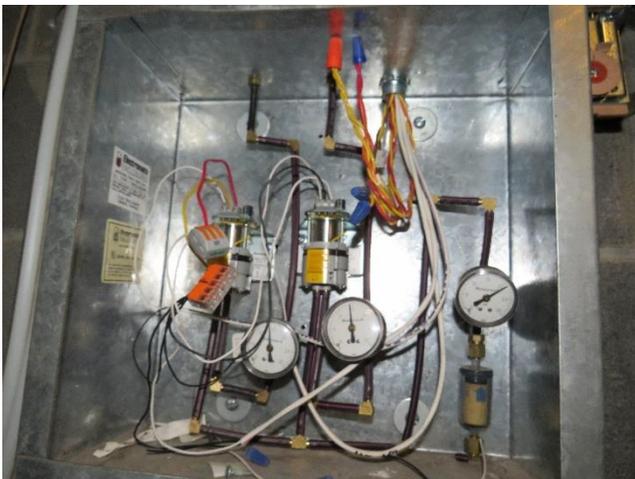
Rm 138 – Utility - Archaic Pneumatic Temp Controls

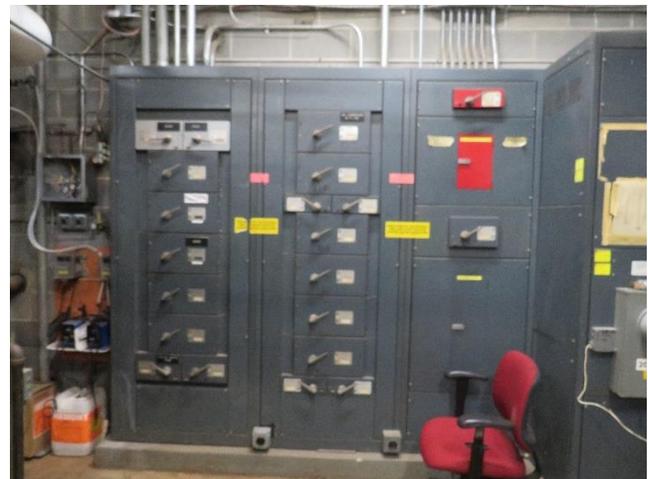
Rm 138 – Utility - Original Electrical Switchgear

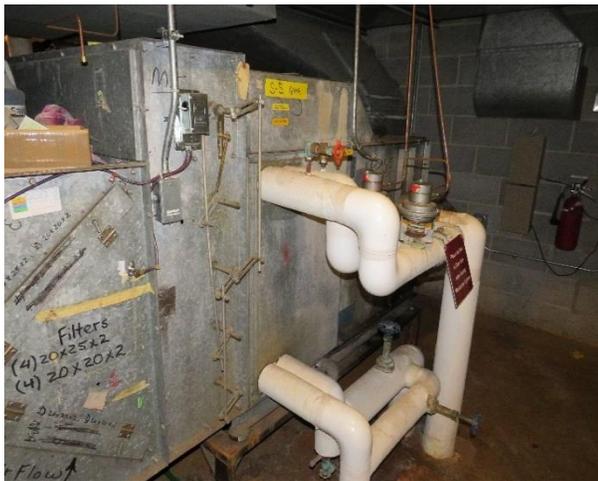
Multiple AHU's Are Past Expected Useful Life

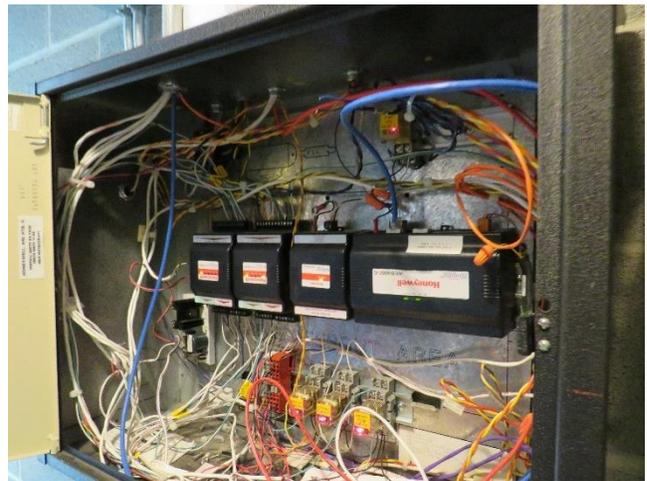
Rm 222 – Mechanical – Archaic Electronic Temp Cntrl's

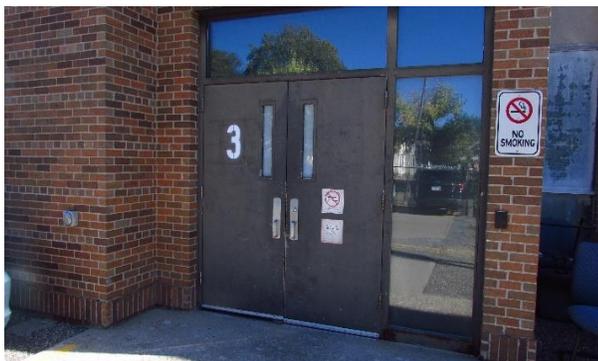
Accessible Entrance No Signage

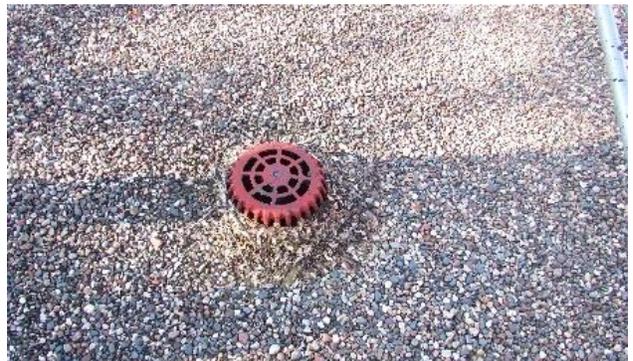
Roof Drains Need to have Debris Remove

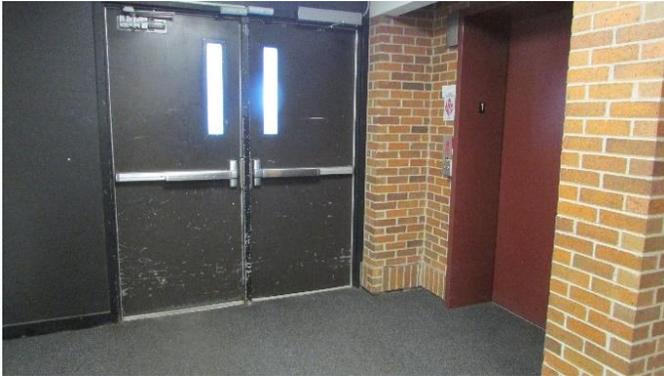
Rm 149 – Vestibule Scraped Doors & Mullion

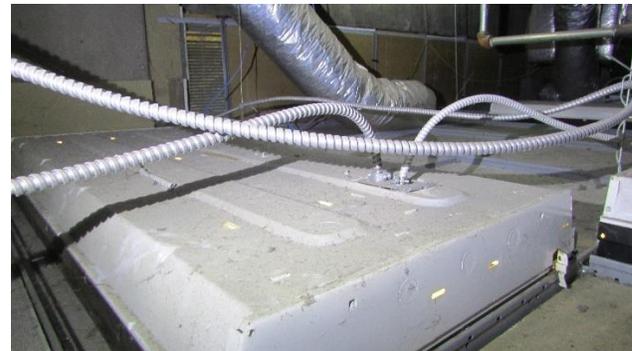
Traffic: Dusty Environment Above Ceiling

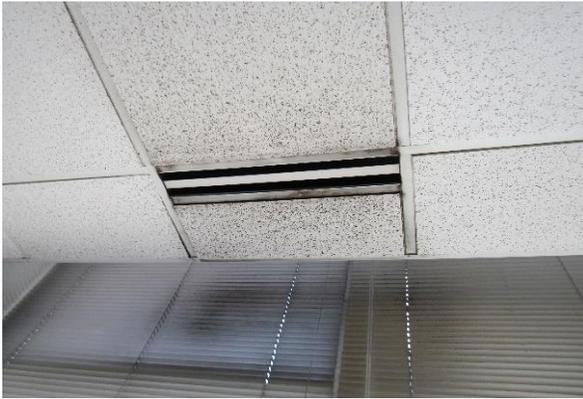
Traffic: Return Air Causing Dirt on Blinds

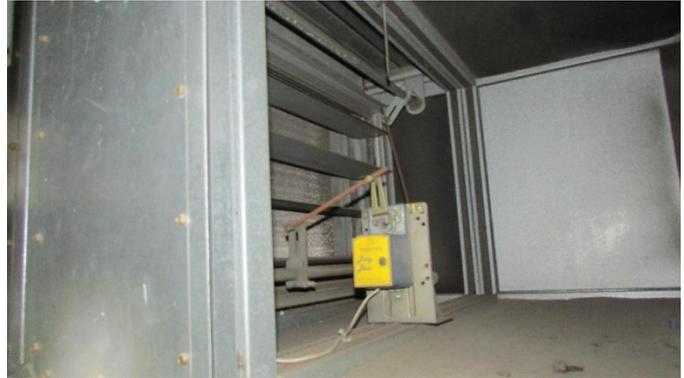
Traffic: Coils Need to be Cleaned

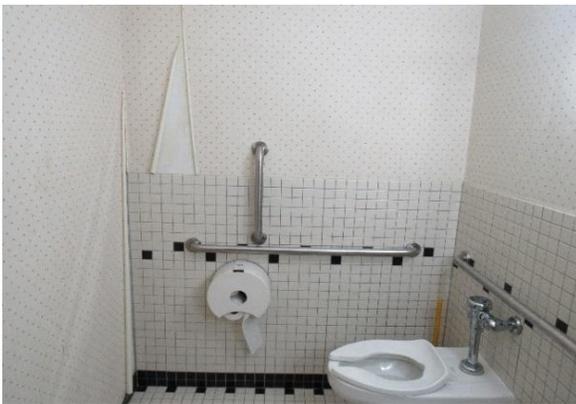
Traffic: Wallpaper Coming off of Walls

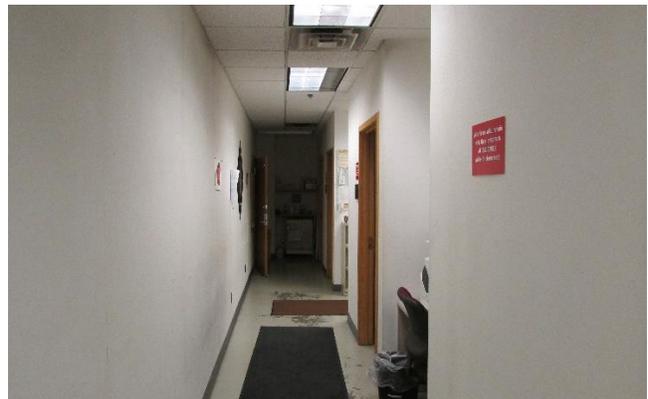
Traffic: Hallway Flooring and Walls – Many Scrapes

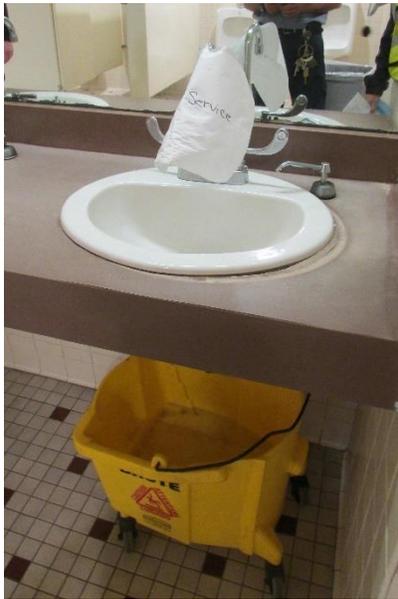
Men's Locker Rm – Sink / Plumbing Issues

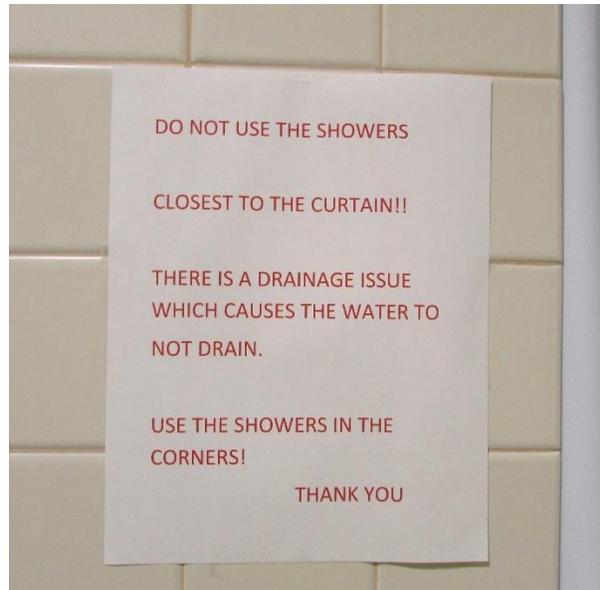
Women's Locker Room – Plumbing Issues

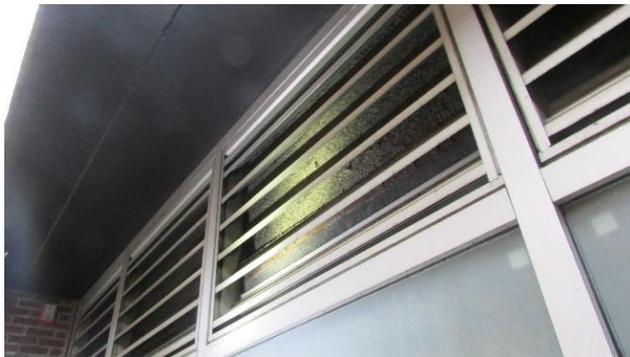
Plugged Outdoor Air Intake for Garage Make-Up Unit

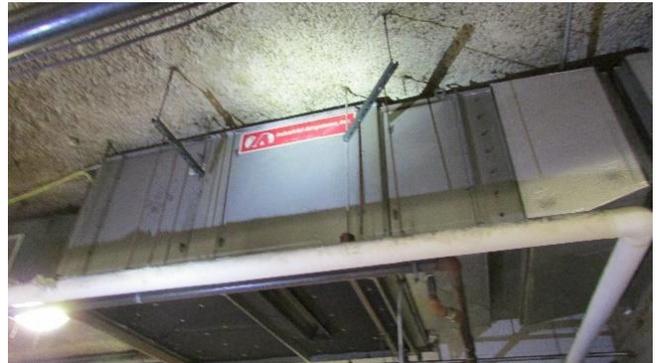
Garage Make-Up Unit – Believed to be Not Oper.
